G. BATISTA
ENGINEERING & CONSTRUCTION

STRUCTURAL INTEGRITY RESERVE STUDY

The Gardens of Kendall South Condominium No.5 Association, Inc.

10835 SW 112th Ave, Miami, FL 33176

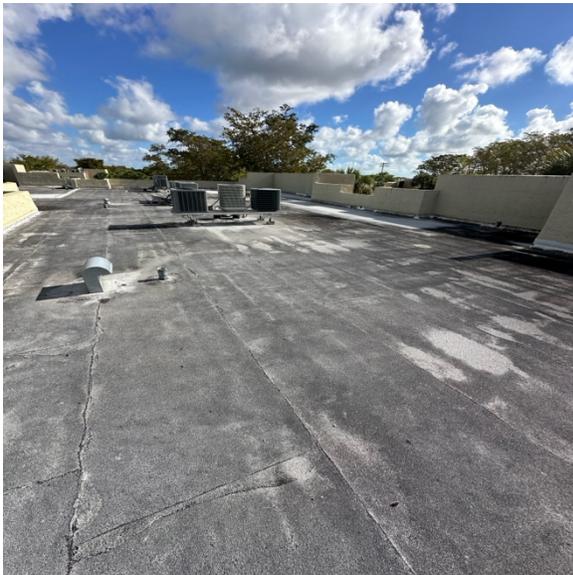
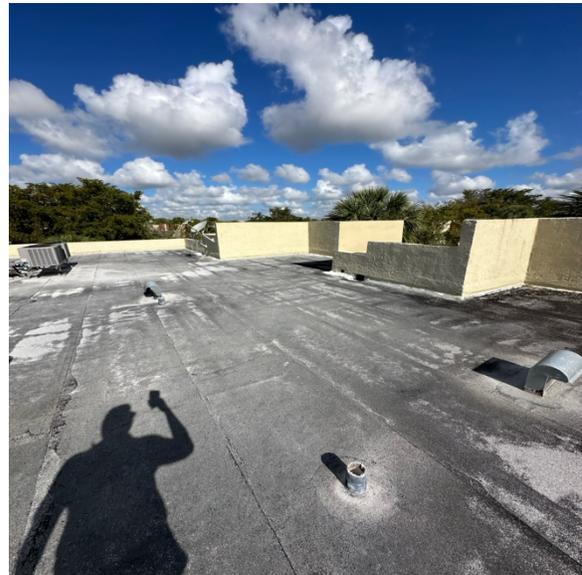
Condition: The roof is in fair conditions.

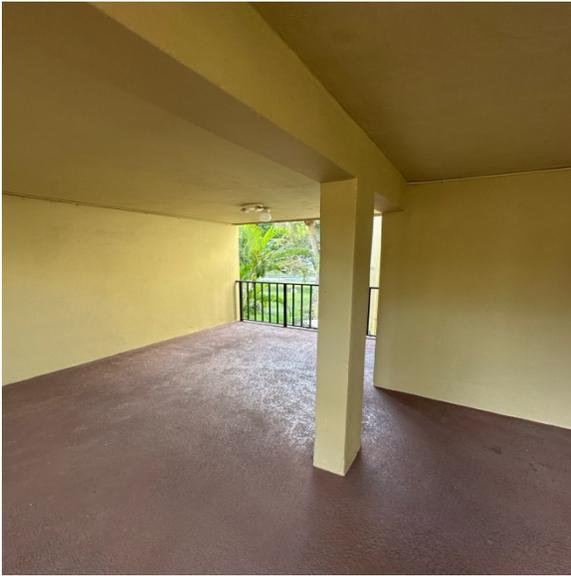
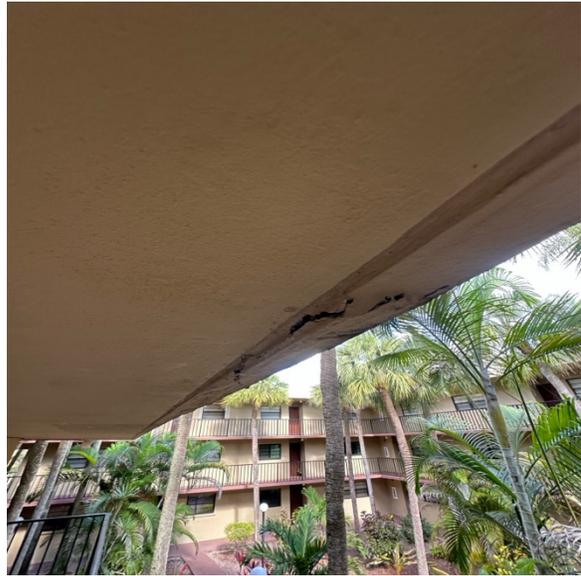
Condition: The concrete framing and floor systems is in unsatisfactory condition.

Remaining Lifespan: Although concrete is a very durable material, due to the location's proximity to the coast, spalling due to rebar corrosion usually manifests before the concrete naturally deteriorates. It is important to note that it is rarely possible to visually inspect and examine all the concealed construction, nor should be generally necessary. Our conclusions are based upon our experience and conditions examined in the exterior typical structural members of the building. Refer to the table presented at the end of this report.

Estimated Cost of Replacement: Concrete repairs are typically done on a unit-price basis and should be repaired as damages appear. Refer to the table presented at the end of this report for our recommendation based on our experience and the size of the building.

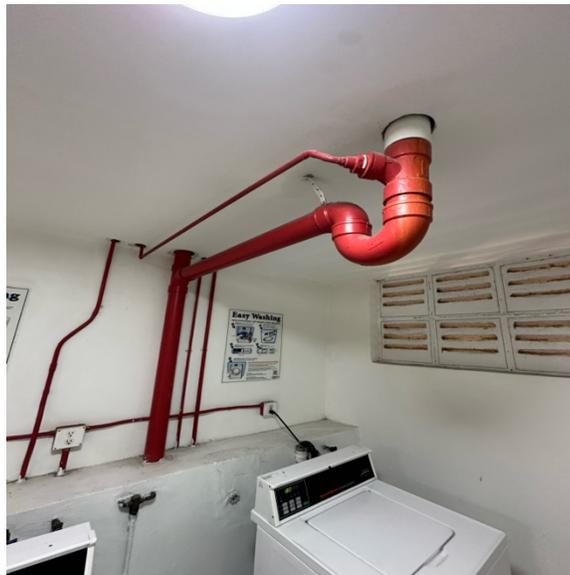
Condition: The plumbing system is in satisfactory condition. It is important to note that it is rarely possible to visually inspect and examine all the concealed construction, nor should be generally necessary. Our conclusions are based upon our experience and deficiencies found in the visible and readily accessible areas.

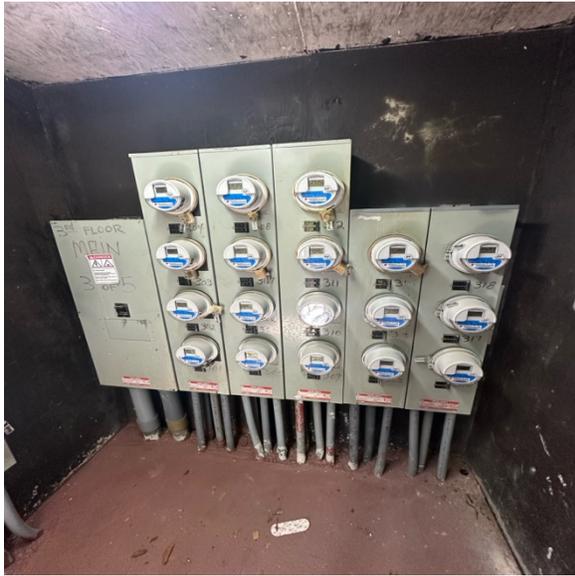
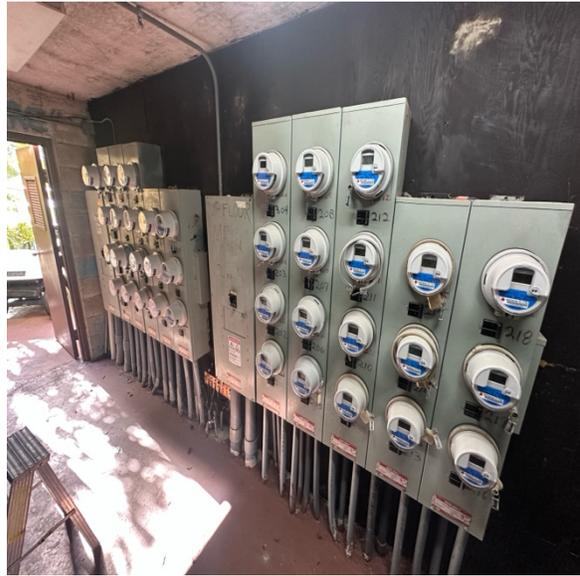
Condition: The electrical system(s) is in satisfactory condition.

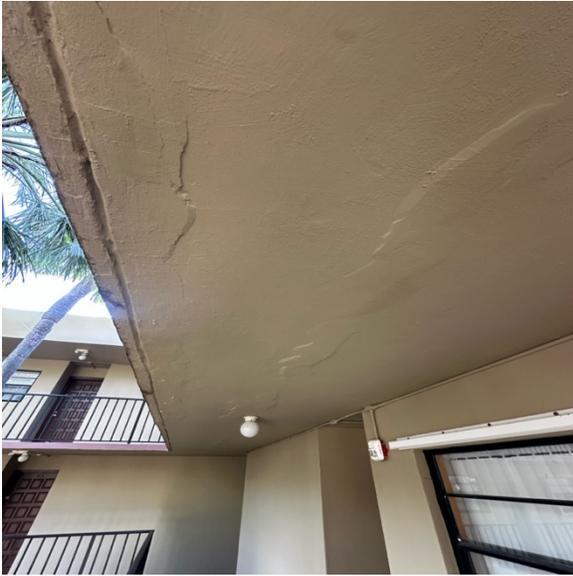
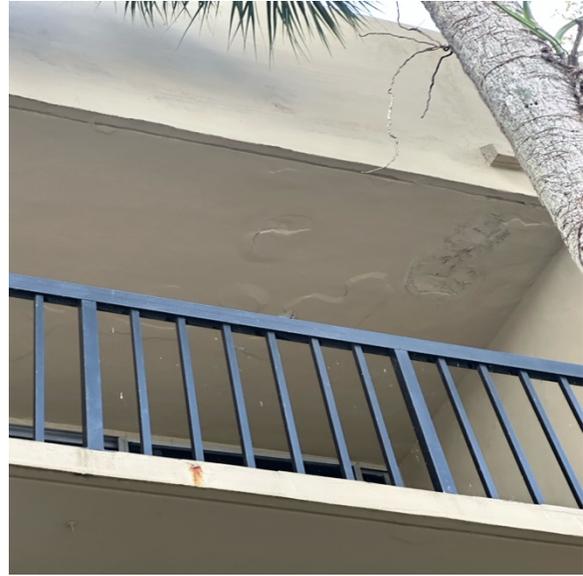
Condition: The exterior stucco is in unsatisfactory condition. It is important to note that our conclusions are based upon our experience and deficiencies found in the visible and readily accessible areas.

Remaining Lifespan: Although the stucco is a very durable material, due to the location's proximity to the shore, spalling due to rebar corrosion usually manifests before the stucco naturally deteriorates. Refer to the table presented at the end of this report.

Estimated Cost of Replacement: The removal and replacement of all the stucco finish is rarely required. It is typically repaired as required in the building for general maintenance. Therefore, we assume that 20% of all exterior surfaces are required to be replaced at once. See the table presented at the end of this report for our recommendation based on our experience and the size of the building. (The exact amount of area needing replacement will be discretionary based on the actual future conditions and the desired appearance).

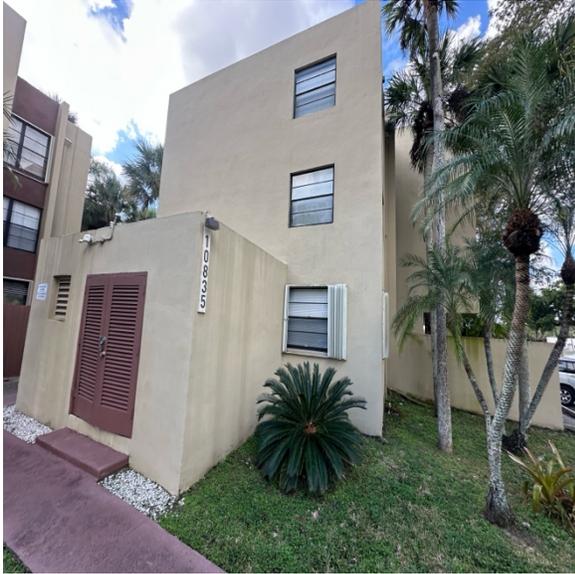
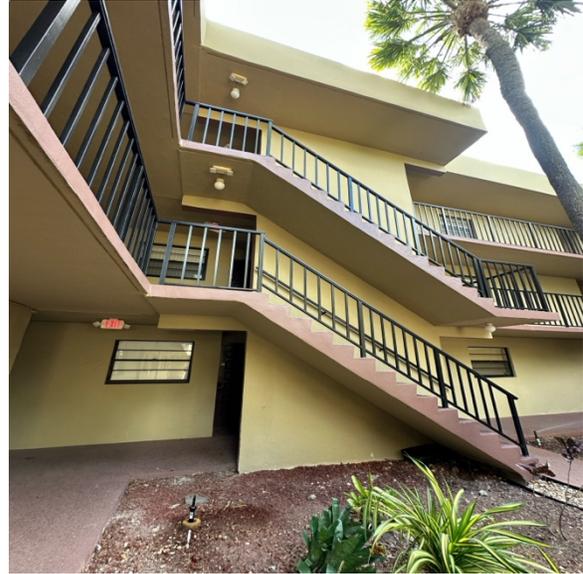
Condition: The surfaces appear to be in unsatisfactory condition.

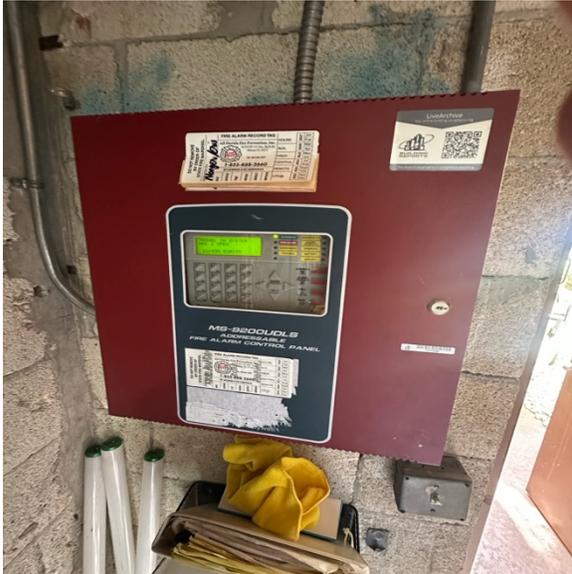
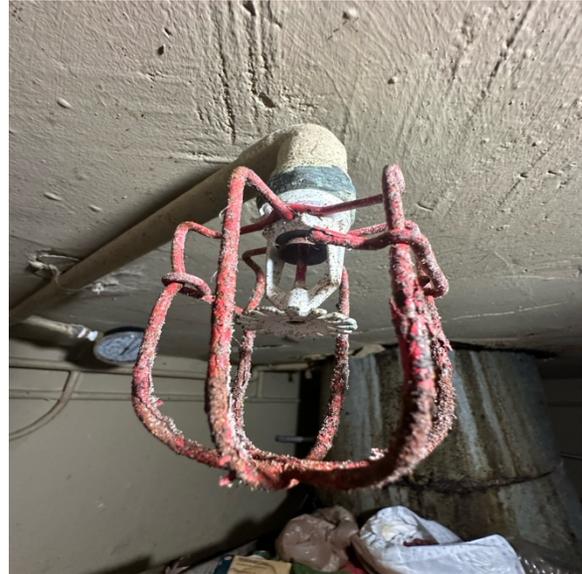
Condition: The fire protection systems appear to be in satisfactory condition.

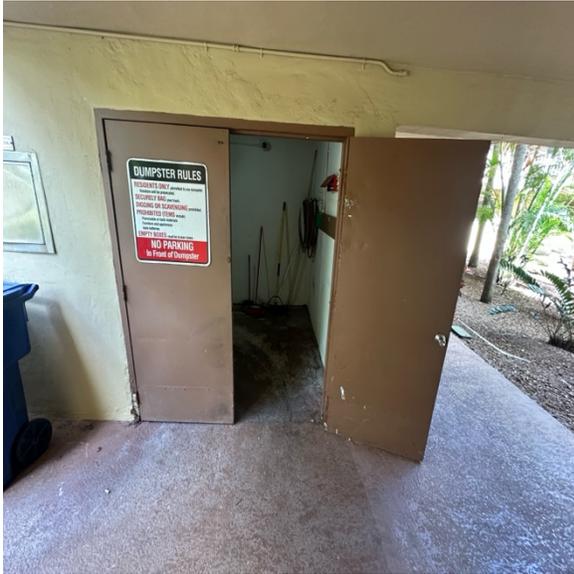
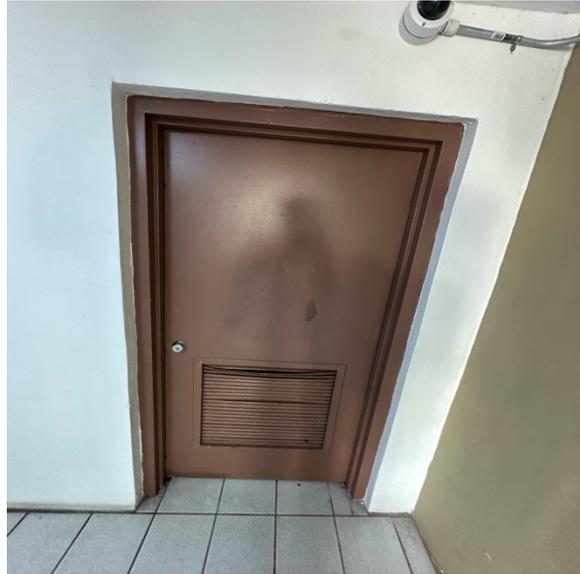
Condition: The common area doors appear to be in satisfactory condition. The association is only responsible for the common areas. The units' windows and doors are the unit owner's responsibility. At the time of our inspection, no common area windows were noted.
